**US Army Corps
of Engineers®**

Engineer Research and
Development Center

Seismic Testing of a 1/20 Scale Model of Koyna Dam

November 2001

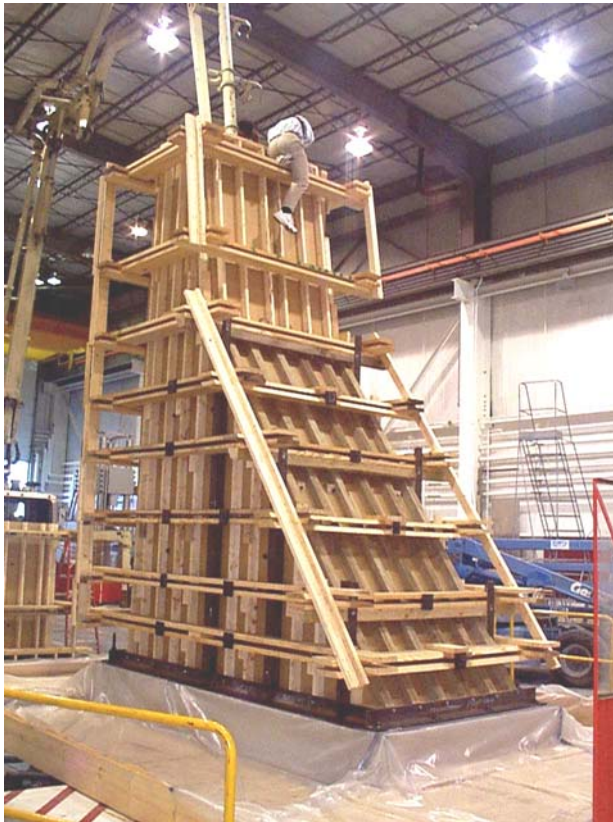
Figure 5. Downstream and front face of dam formwork.

The formwork was designed to resist the full hydrostatic pressure of the model material. The concrete used in the dam model was very fluid and was not expected to set-up until 24 hours after casting. Also, because of the fluid consistency of the concrete, the formwork needed to be almost watertight. Figure 5 shows the downstream and front face of the dam formwork soon after casting began. Note the pump line at the left side of the photograph. Figure 6 shows the back face of the dam formwork. The top of the formwork was 12 in. (0.305 m) above the top of the model so the material could be cast several inches above the desired elevation, allowing for the significant predicted settlement after casting. Specifically, a 2 percent reduction in concrete volume due to settlement was predicted, which meant the elevation at the top of the forms would drop almost 10 in. (0.25 m), leaving 10 in. (0.25 m) of water at the top. Appendix A provides more details on formwork design and detailing. The formwork was almost entirely wood, but incorporated steel angle irons to resist the uplift forces from the sloped downstream face. Vertical steel angles on the front and back faces transferred loads from the downstream walers to horizontal angles at the base of the model. Horizontal angles went around the perimeter of the formwork and anchored it to the base beam during casting.

During seismic testing, the model was expected to crack across the entire cross-section, beginning at the change in slope on the downstream face. Appendix A explains how the overhead crane was attached to the section above the expected crack to stabilize it and prevent it from falling onto the shake table or actuators. However, a remote possibility remained that this entire 14,000 lb (6350 kg) portion of the model could break free from the insert connections and fall in the upstream direction 13 ft (4.0 m) down to the TESS actuators below. To minimize any damage arising from such an unlikely event, a TESS protection frame was constructed. Figure 7 shows the Koyna dam model during modal testing using a 50 lb (222 N) shaker at its top, with the TESS protection frame around its base. This protection frame was designed to also serve as a "moat" during casting. However, the protection frame construction could not be completed in time for casting, so a simple moat was temporarily constructed for casting. It consisted of 2 x 12s (nominal lumber measurements, inches) on edge about 4 ft (1.2 m) from the base beam and plywood on the TESS surface. The entire surface, from the top of the base beam to the edge of the moat, was covered with plastic sheets which can be seen at the bottom of Figure 5. Appendix A provides details on the design of the TESS protection frame.

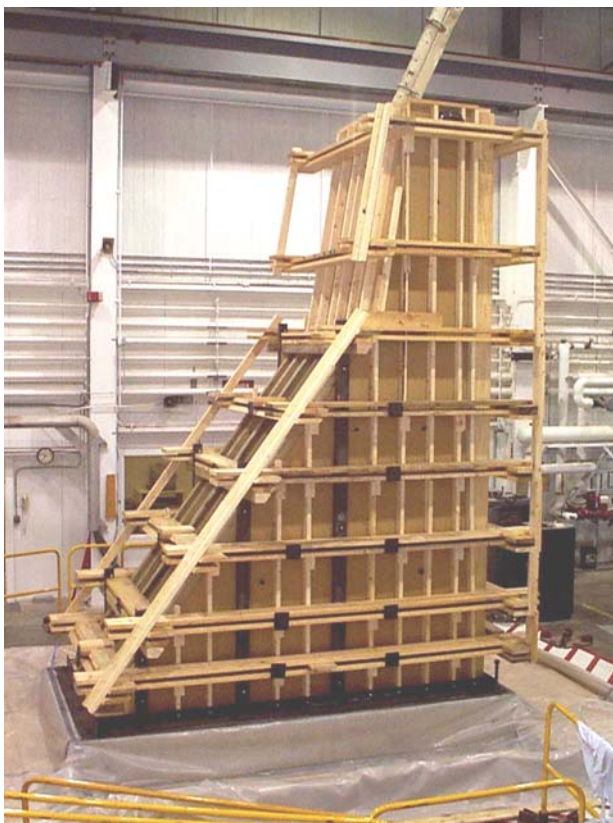
Figure 6. Back face of dam formwork.

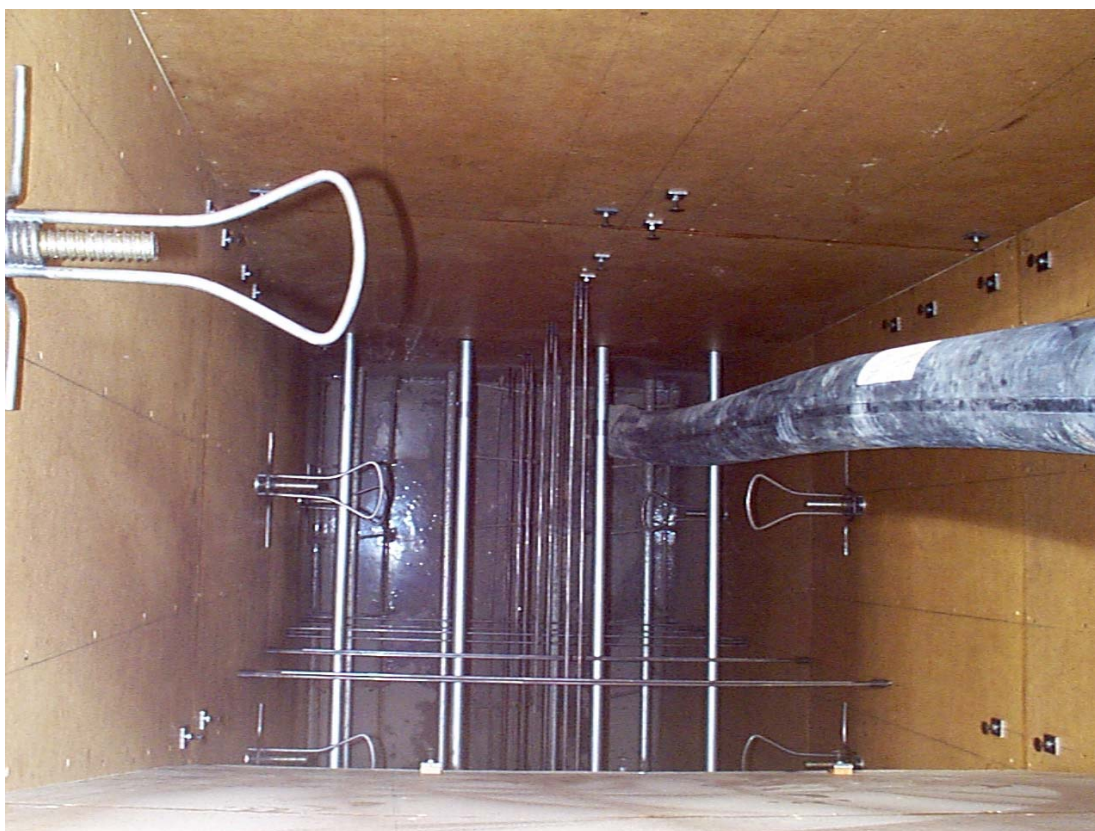
Figure B2. The rubber hose discharging material into the model formwork.

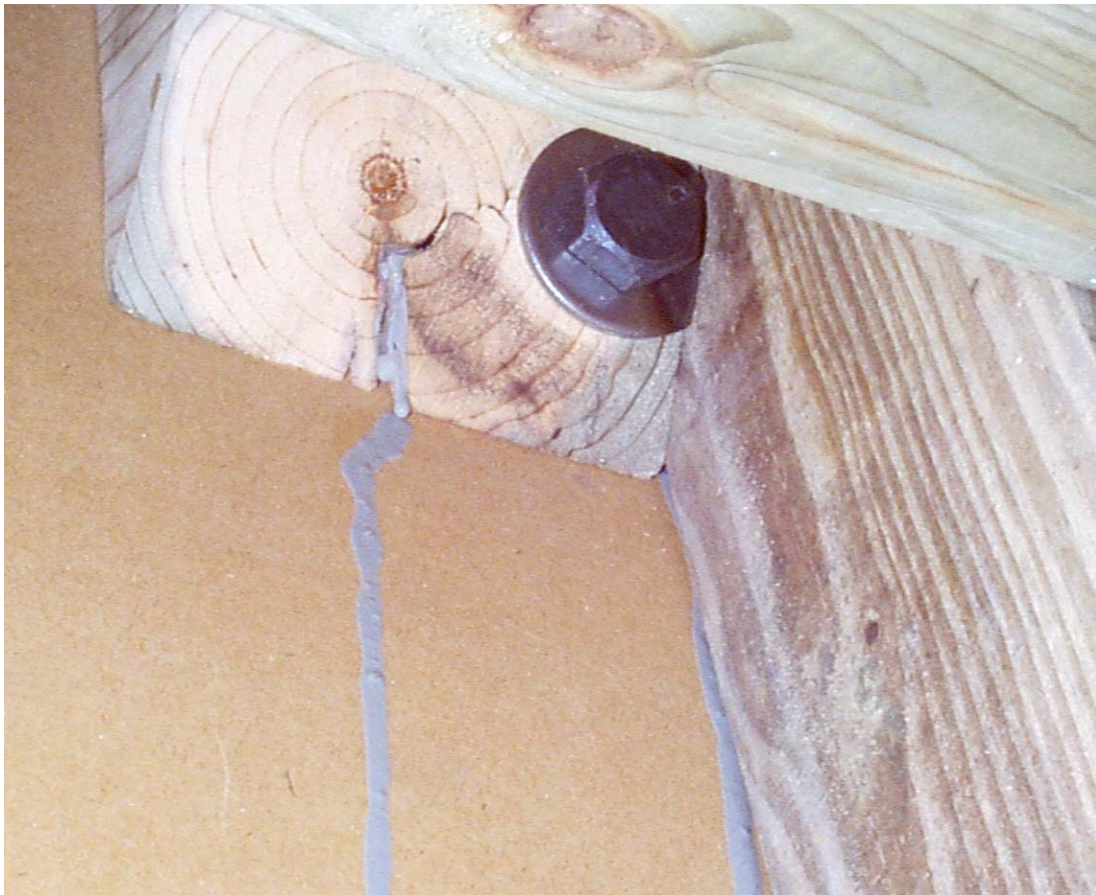
Figure B3. Leaks on the downstream face where a coil-tie bolt penetrates the formwork.

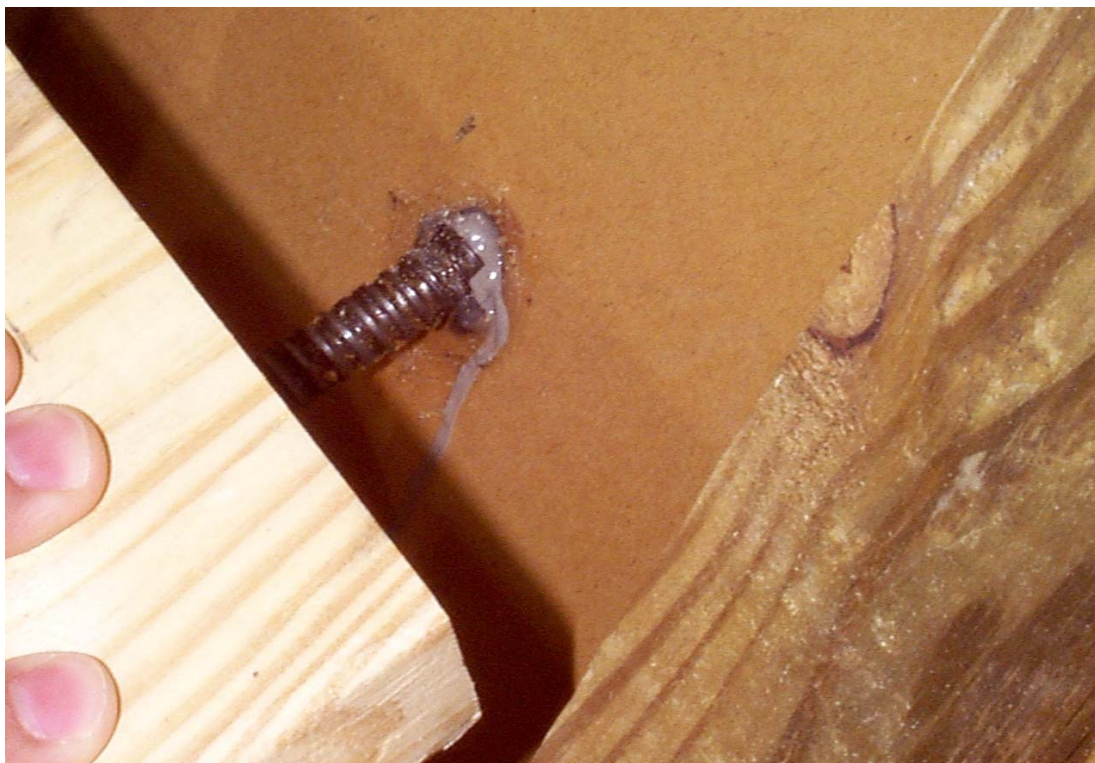
Figure B4. Leak on downstream face where coil-tie bolt for waler support penetrates formwork.

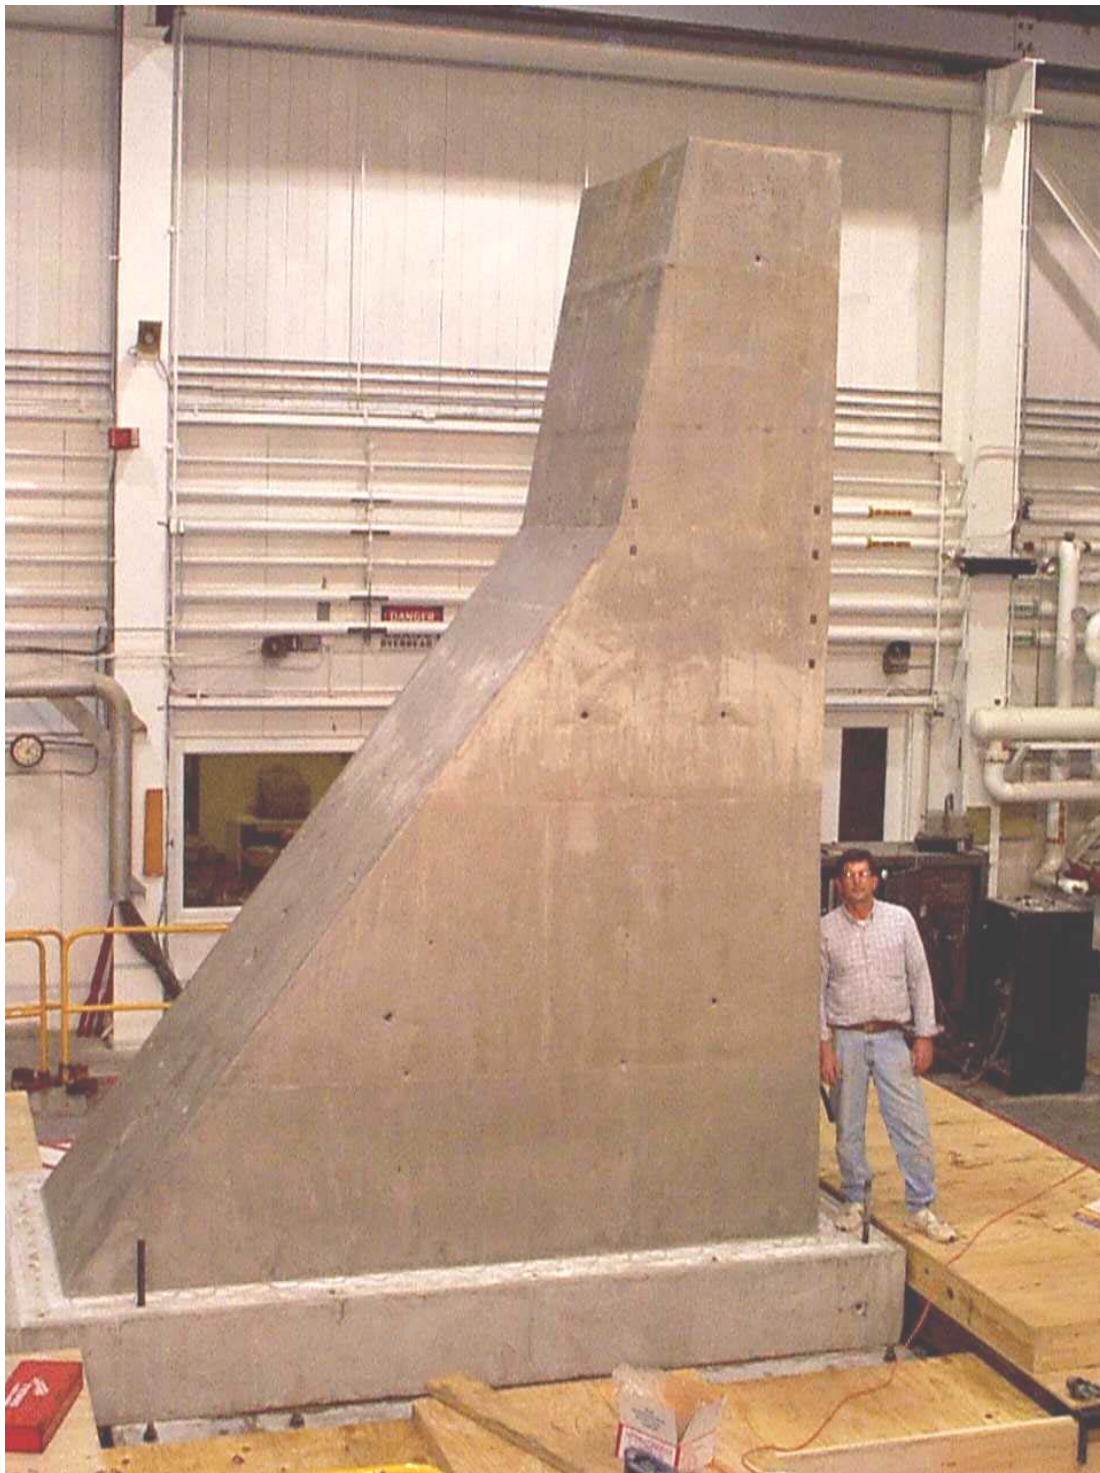
Figure B5. Back face of Koyna dam model after the application of curing compound, but prior to whitewash application.

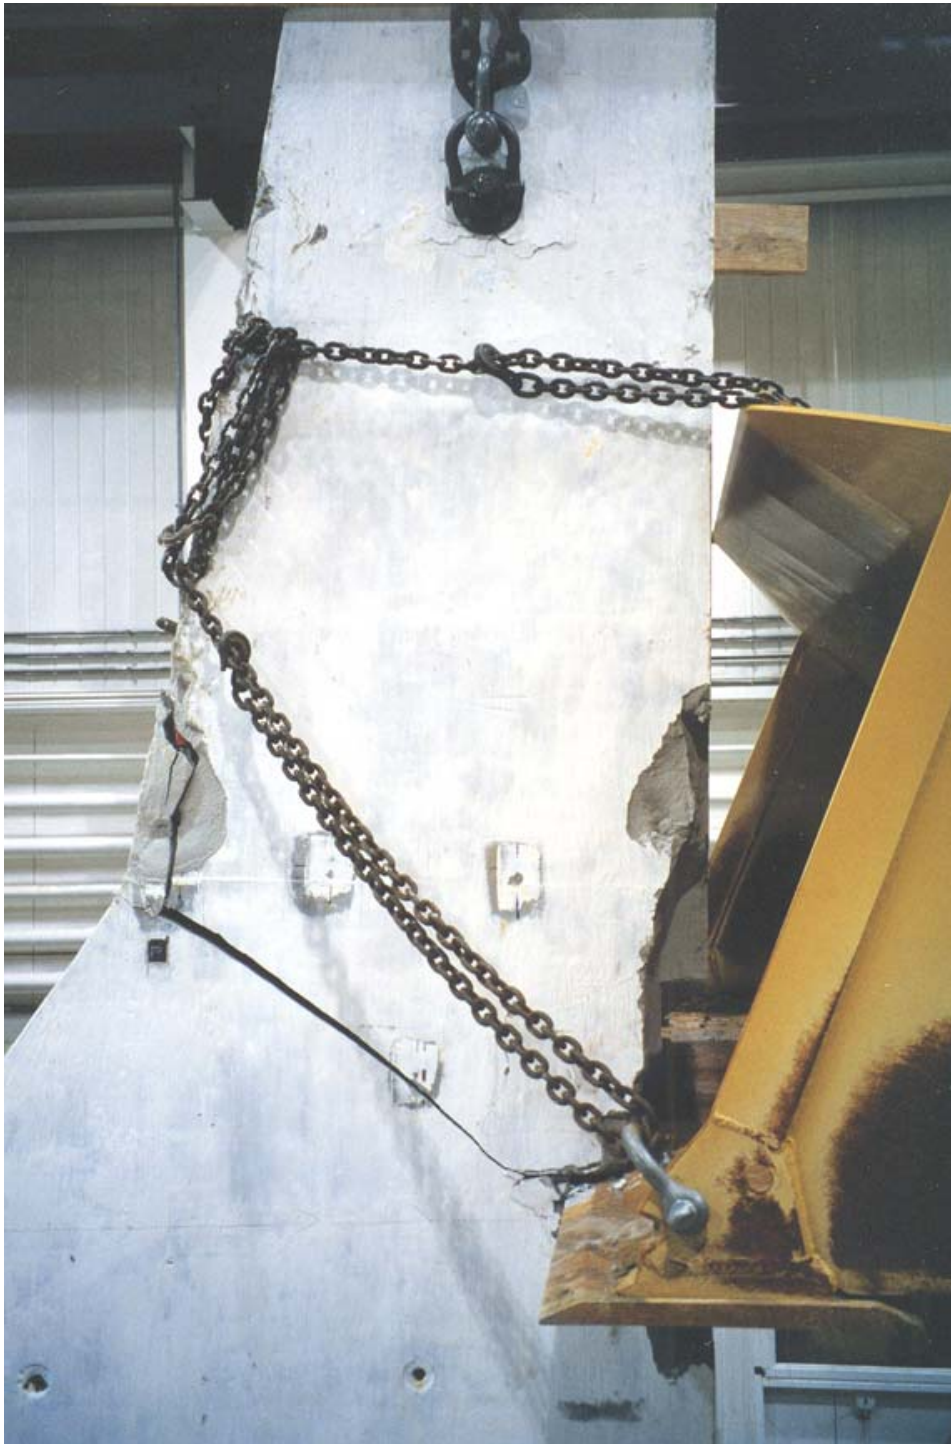
Figure D1. Removing top section of model with tractor and overhead crane.

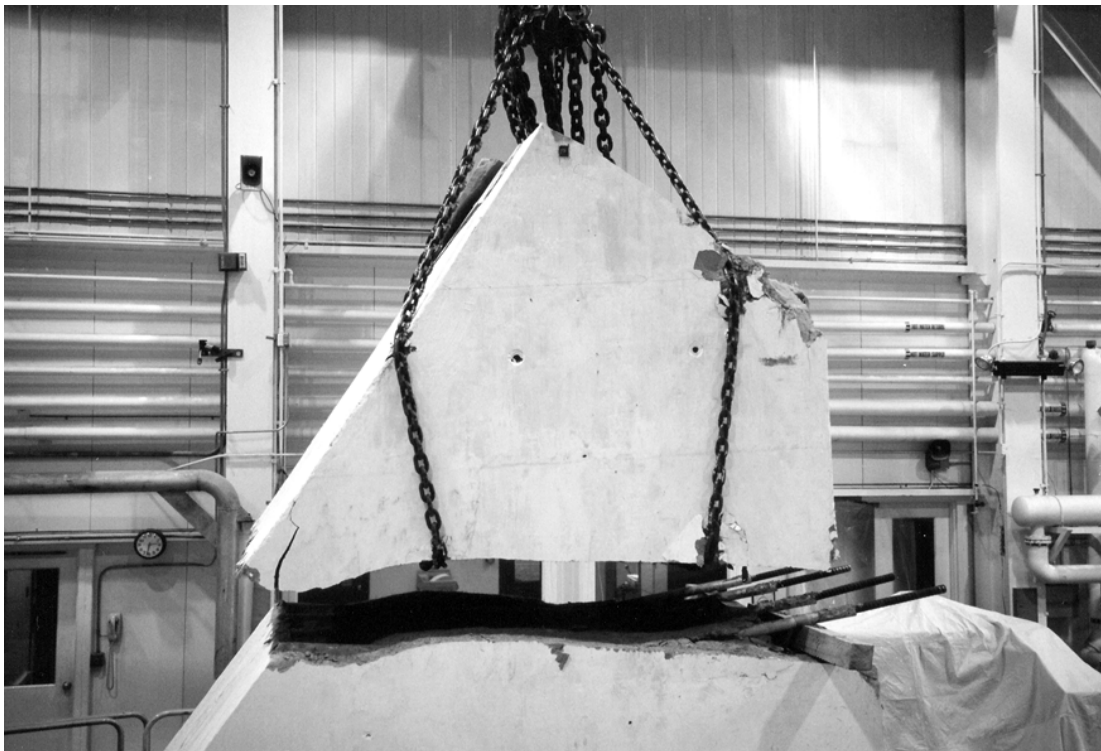
Figure D3. Lifting of the failed section of the model with the overhead crane.

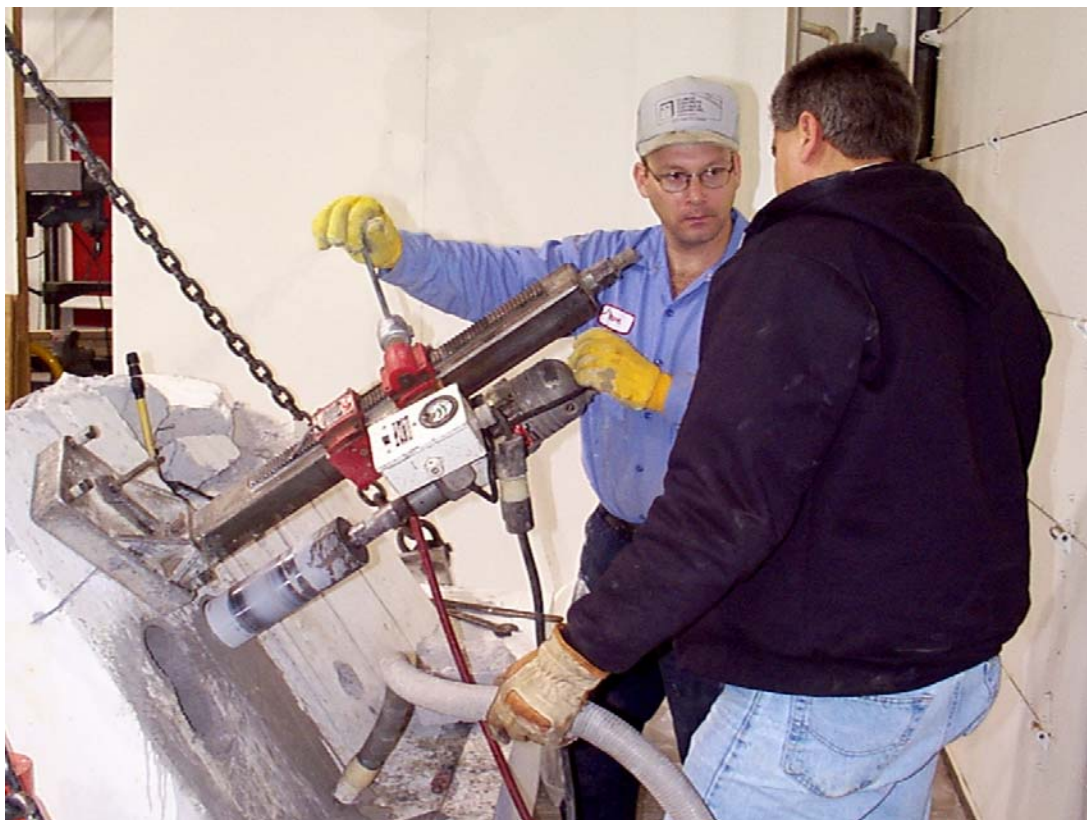
Figure D4. Drilling core samples near the base of the model.

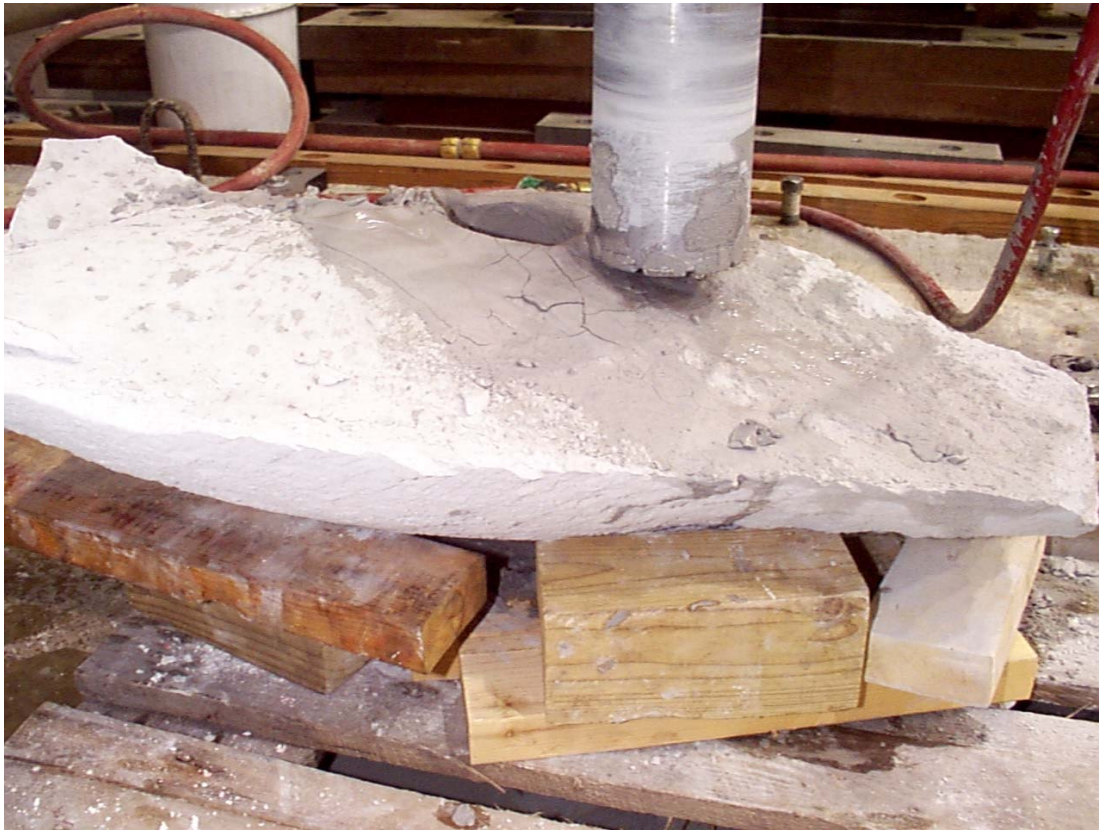
Figure D6. Drilling core samples from a section near the primary crack.
